# Watershed Action Plan

## Lake Eden Watershed

### Eden, Vermont

December 20, 2019

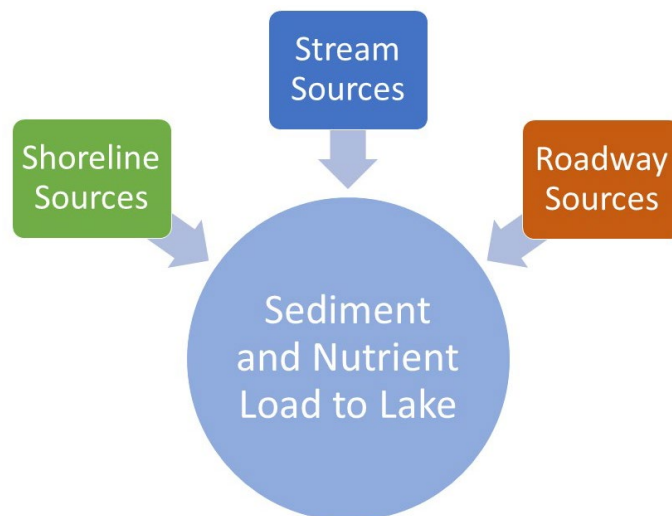
**Figure 1:** Conceptual diagram of primary water quality stressors on Lake Eden.

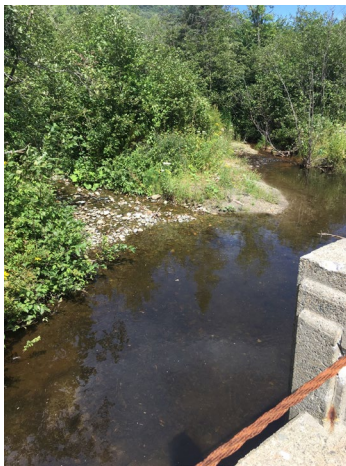
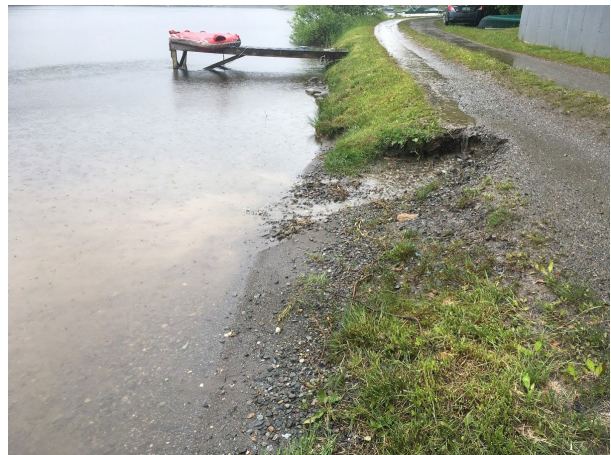
**Figure 4:** A culvert on the Gihon River with poor channel alignment had the lowest problem area score (left photo, Project SC-3). Erosion and transport of sediment from Lake Shore Road directly to the Lake was the highest problem area score (right photo, Project SW-11).

4. **Project SW-11/17: Lake Shore Road** – This Class 4 Town Road lacks a lakeshore buffer and is concentrating runoff. A seasonal gully may form on the eroded embankment, that directly inputs sediment into the lake. A steep stretch of road lacks drainage ditches, causing severe rill erosion for approximately 150 feet near the eastern bend in the road. This runoff continues to the lakeshore, exacerbating the gully erosion on the stretch of road without a lakeshore buffer.

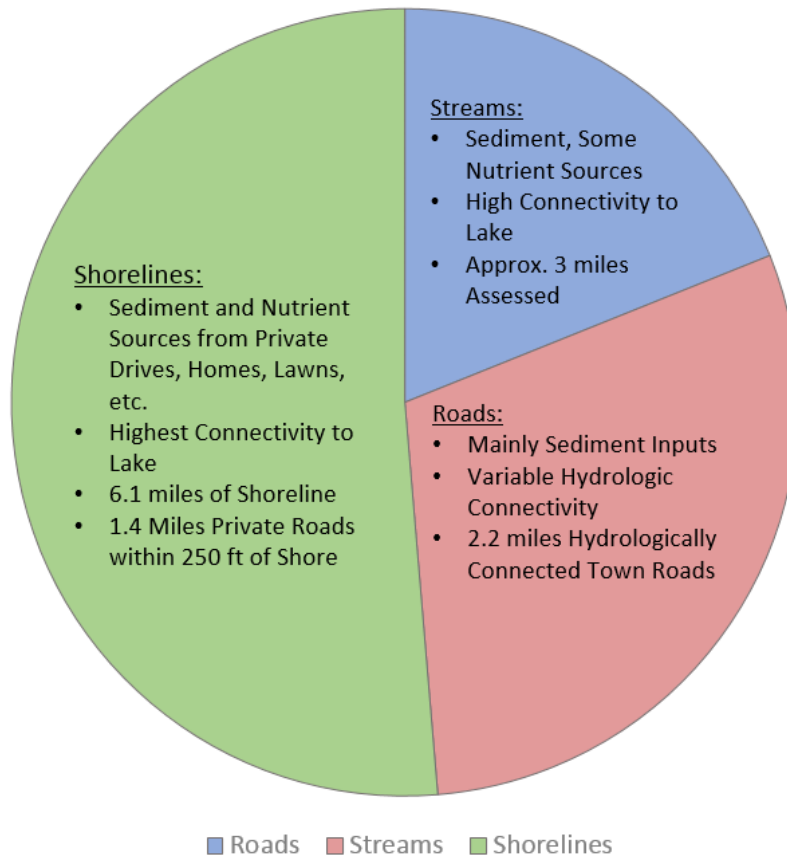
**Figure 5:** Relative contribution of sediment/nutrients to Lake Eden from various sources.

Based on the distribution of project types, as well as each project’s watershed location, size, and existing nutrient/sediment load, we estimated the relative load from each of the primary “sectors” of the Lake Eden watershed. Given the high degree of development along much the lake’s shoreline, as well as the extensive network of private gravel roads and driveways near the lakeshore, it is our opinion that the lakeshore represents the largest contribution of sediment and nutrients to the Lake. Municipal roadways and associated drainage from roadways likely represents greater than ¼ of the load, while stream bed and bank erosion appears to represent less than ¼ of the load (Figure 5).

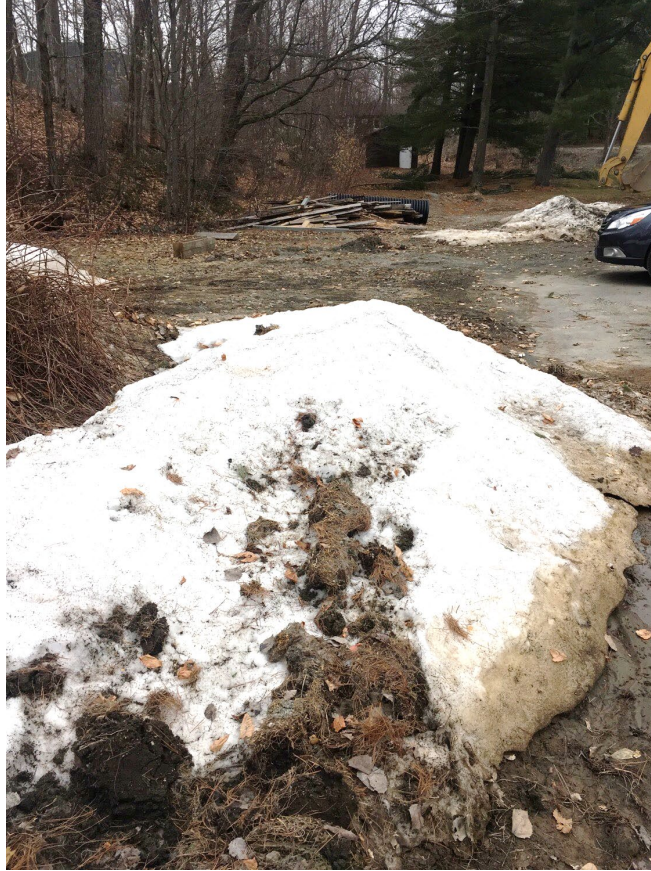
Figure 6: Part of a large paved parking lot at the Boy Scout Camp.

parking area at the Boy Scout Camp. Total impervious area at the Camp exceeds 1 acre, and significant drainage problems around the facility have been noted by Camp staff. The location of snow storage for the parking lot may be contributing extra runoff to the channel.

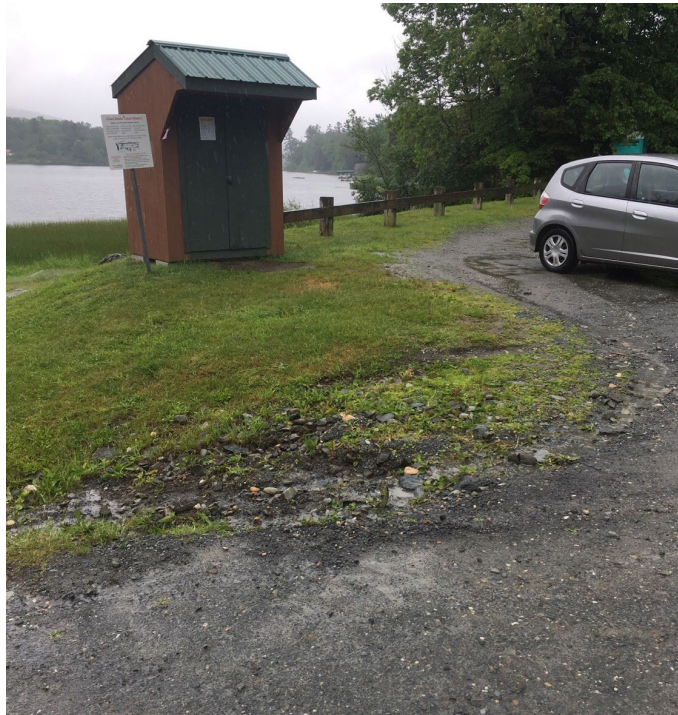
**Figure 7:** Erosion at the VT Fish and Wildlife Boat access observed during a storm event in June 2019. The concept design for this area (SW-4) describes a BMP that would treat this runoff.

1. **Project SW-4: Vermont Fish and Wildlife Boat Launch** – Concentrated runoff from Route 100 is causing rill erosion near the cross-culvert inlet conveying water to the adjacent wetland, and directly to the lake. The recent addition of water bars has helped intercept flow from Route 100, but opportunities remain to improve infiltration and sediment retention on-site. The sediment load at the site may be exacerbated by accumulation of gravel in the winter from plowing.
2. **Project SW-5: Boy Scout Camp Parking Lot** – An eroded channel and gully where the channel enters the stream is forming from stormwater runoff concentrated along the western side of the
